# Manhole Inspection Summary

Manhole # S21E\_\_014MH

Insp Date: **10/16/07 9:21 AM**

**Location** Address: **214 PAYSON-MONROE**

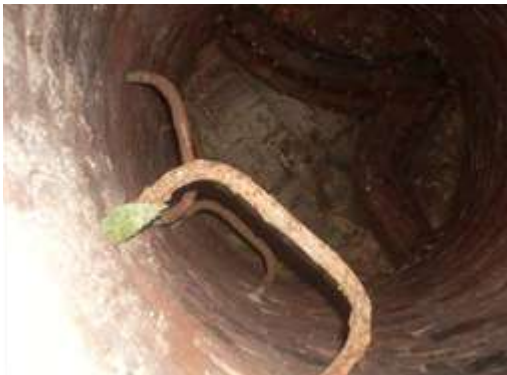
Defect 4

**Steps** Count: **4** Missing: **0** ☒ **Corroded**

CORRODED STEPS

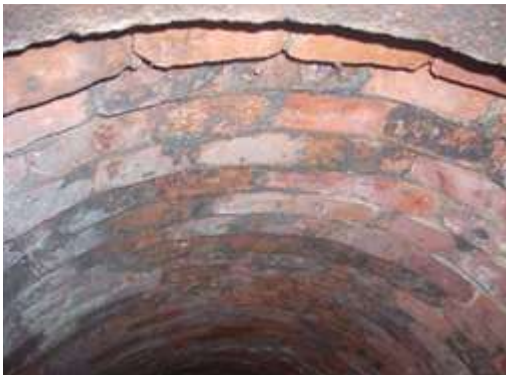
Defect 3

Infiltration: ☐ None ☐ Joint ☐ Cracks ☐ Mortar ☐ Roots ☒ **Wall**

INFILTRATION OF THE CORBEL WALL

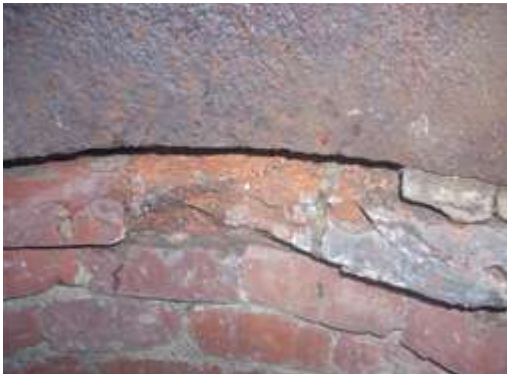
Defect 2

Condition: ☐ Sound ☐ Cracked ☐ Root Intrusion ☐ Loose Brick ☒ **Deteriorated**

DETERIORATED CORBEL

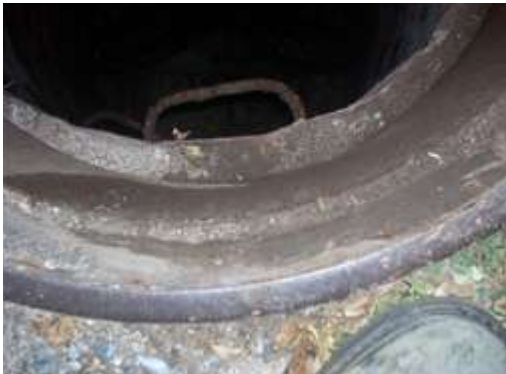
Defect 1

**Frame** Offset: **2** (in.) Condition: ☒ Sound ☐ Cracked ☐ Leaks

FRAME OFFSET

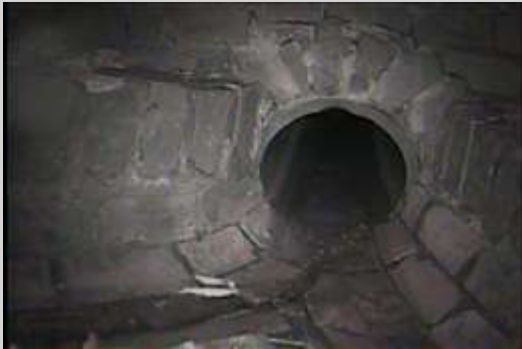
12 O'Clock Outflow

8 in. Circular Gravity Sewer  
Pipe Out @ 12 O'Clock

Pipe Height: **7.2** (in.) Rod and Bar (Angled)  
Pipe Material: **Clay** ☐ Pipe Lined  
Invert Depth: **9.07** (ft.) Flow Characteristics: **Slow**  
Deposits: ☒ None ☐ Mud ☐ Sludge ☐ Debris ☐ Grease  
Silt Depth: (in.) Deposits Extent:  
Infiltration: **None** Pipe Seal Cond: **Sound**

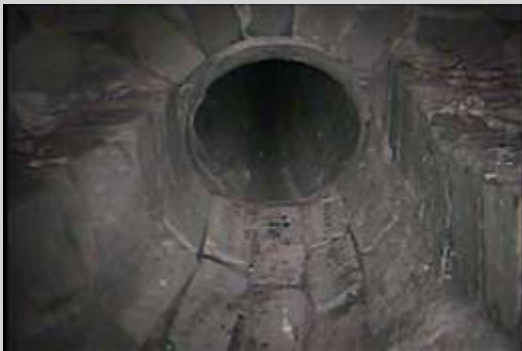
3 O'Clock Inflow

8 in. Circular Gravity Sewer  
Pipe In @ 3 O'Clock

Pipe Height: **7.2** (in.) Rod and Bar (Angled)  
Pipe Material: **Clay** ☐ Pipe Lined  
Invert Depth: **8.77** (ft.) Flow Characteristics: **Slow**  
Deposits: ☒ None ☐ Mud ☐ Sludge ☐ Debris ☐ Grease  
Silt Depth: (in.) Deposits Extent:  
Infiltration: **None** Pipe Seal Cond: **Sound**

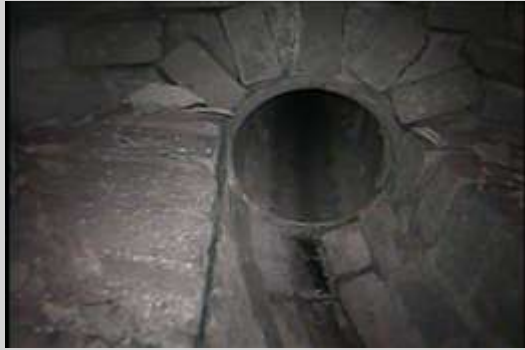
9 O'Clock Inflow

8 in. Circular Gravity Sewer

Pipe In @ 9 O'Clock

Infiltration: **None** Pipe Seal Cond: **Sound**
